HEAT-STERILIZABLE, REMOTELY ACTIVATED  
BATTERY DEVELOPMENT PROGRAM  
PHASE II  
Fourth Quarterly Report

Period: April 1, 1969 to June 30, 1969

Contract No. 952214

ELECTRONICS DIVISION  
Eagle-Picher Industries, Inc.  
Couples Department  
Joplin, Missouri

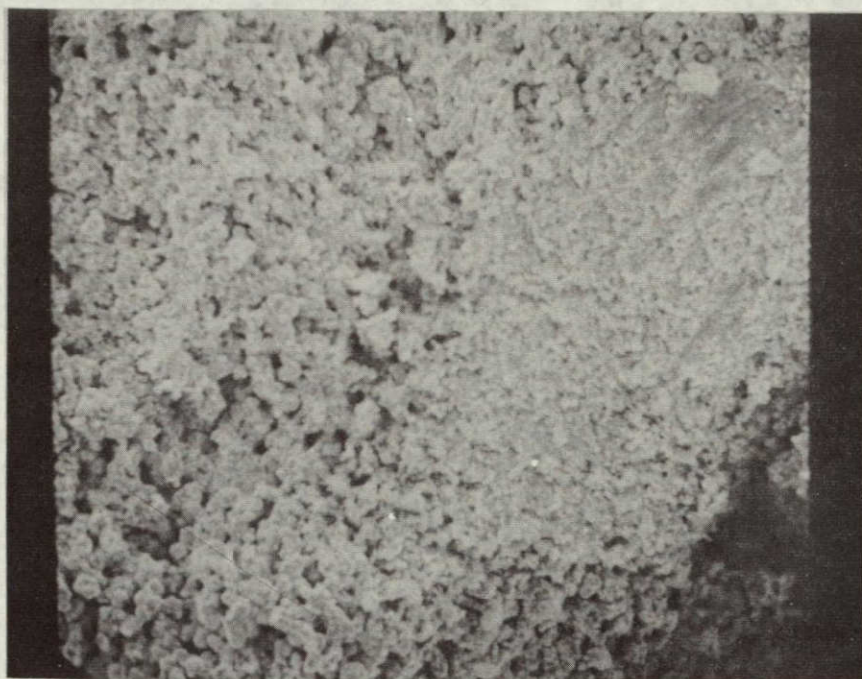
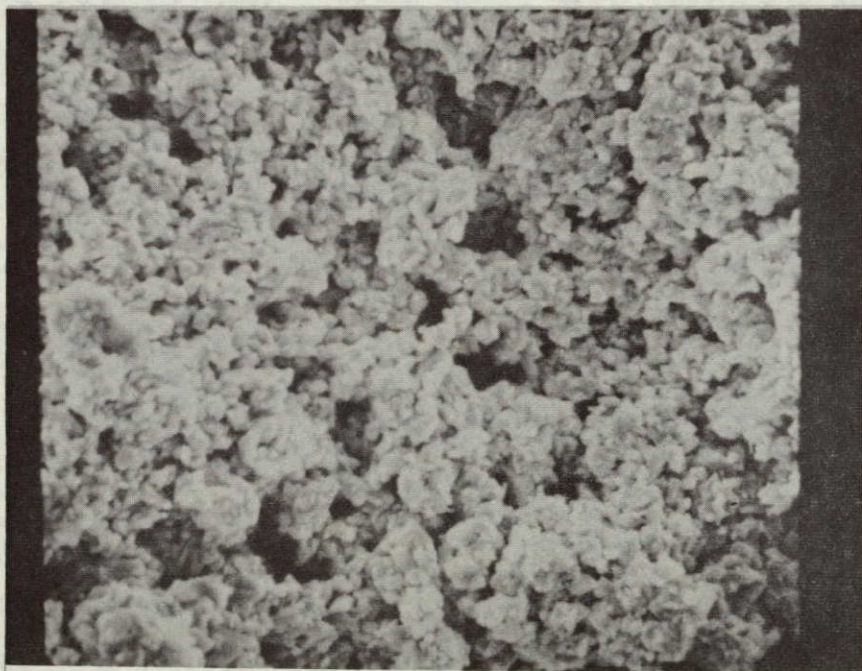
Silver Oxide Plate No. 35

Sterilized

Flat Surface

The structures of all the samples appeared to become much more similar after sterilization. An overall agglomeration occurred with less apparent void space. There were no longer any of the individual angular particles that were present initially. All the particles appeared to be made up of a large number of small particles of about micron size.

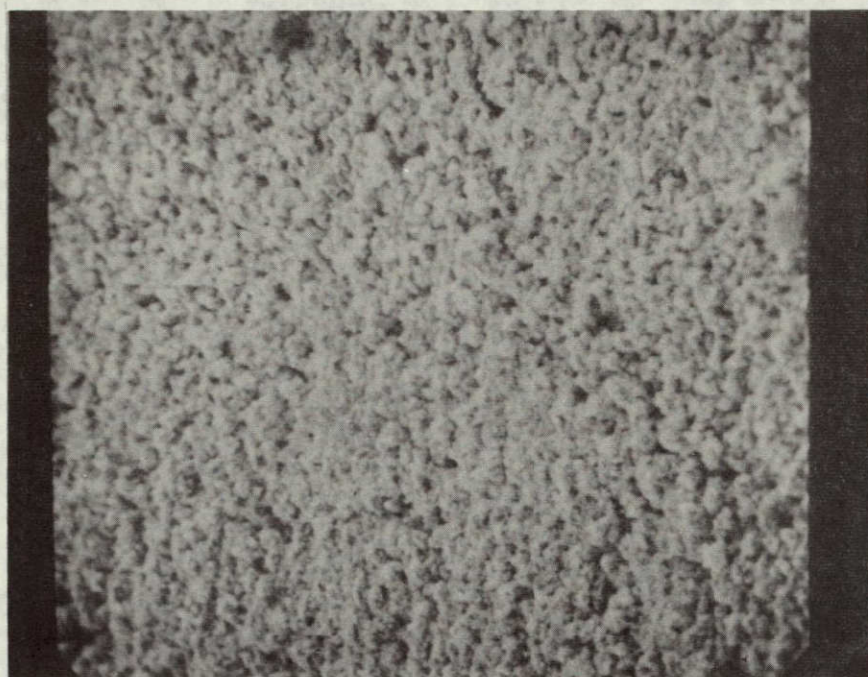
Silver Oxide Plate No. 83

As Received

Flat Surface

One noteworthy feature is the very angular nature and large overall size of the AgO at lower weights and density. The porosity or void area is also extensive for these electrodes. Both the structure and void area change considerably with increased weight and density. The angularity is not evident and the particles tend to form a more continuous mass, made up of smaller, more rounded agglomerated particles.

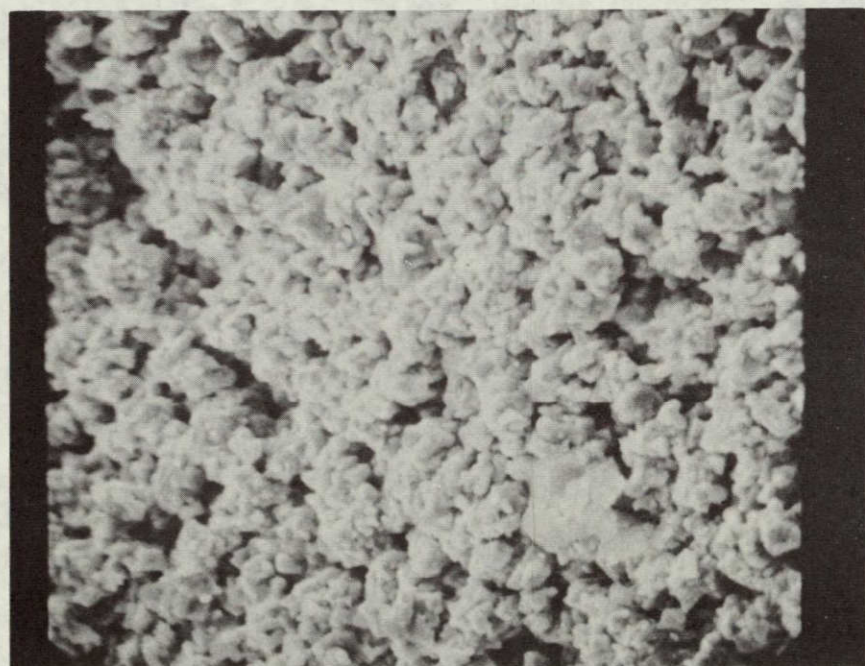
Silver Oxide Plate No. 95  
As Received  
Transverse View

The transverse shots revealed irregularities or variations in density through the thickness of the electrodes. This was due to the pressing operation and pressure variations through the thickness caused by both depth and the presence of the silver grid. In general, however, the electrode structure was fairly uniform.

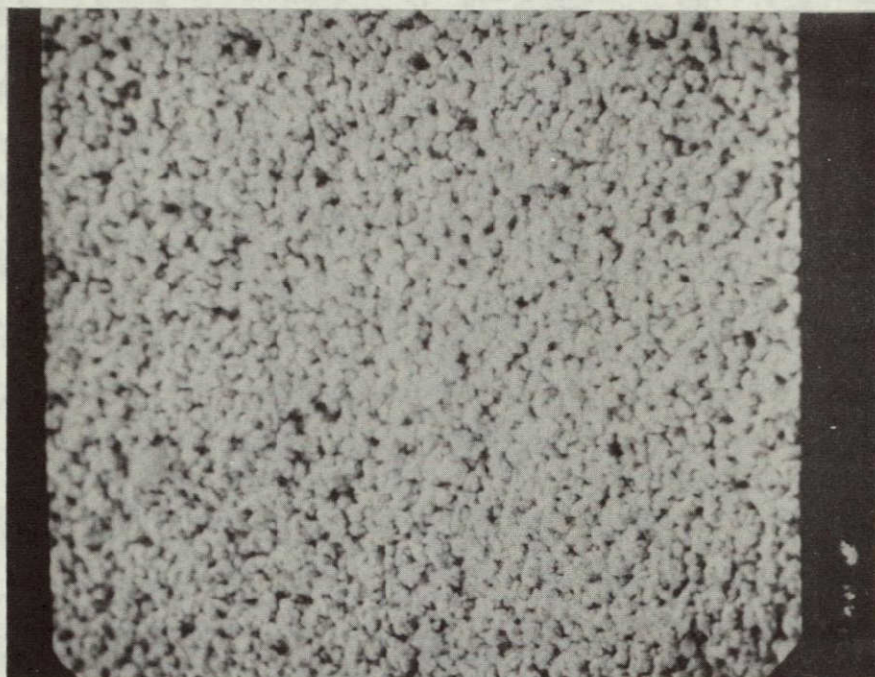
1000 Magnification  
Silver Oxide Plate No. 95  
Sterilized  
Flat Surface

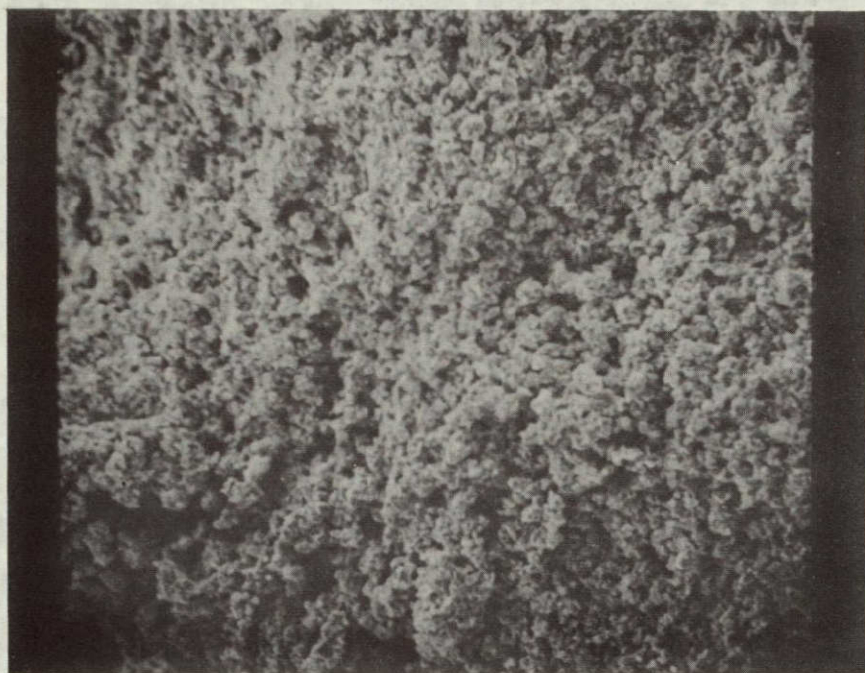
Silver Oxide Plate No. 106

Sterilized

Flat Surface

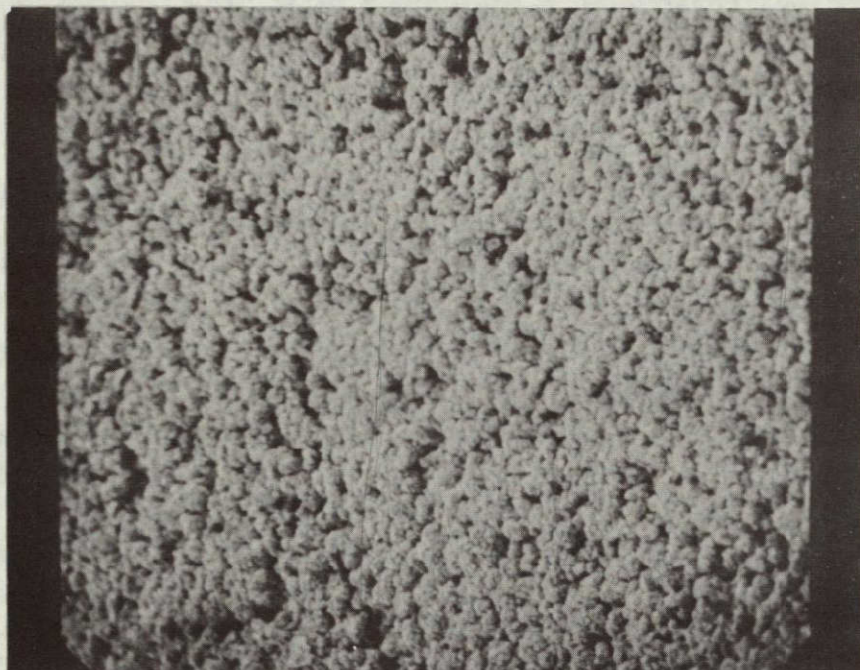
1000 Magnification  
Silver Oxide Plate No. 120  
As Received  
Flat Surface

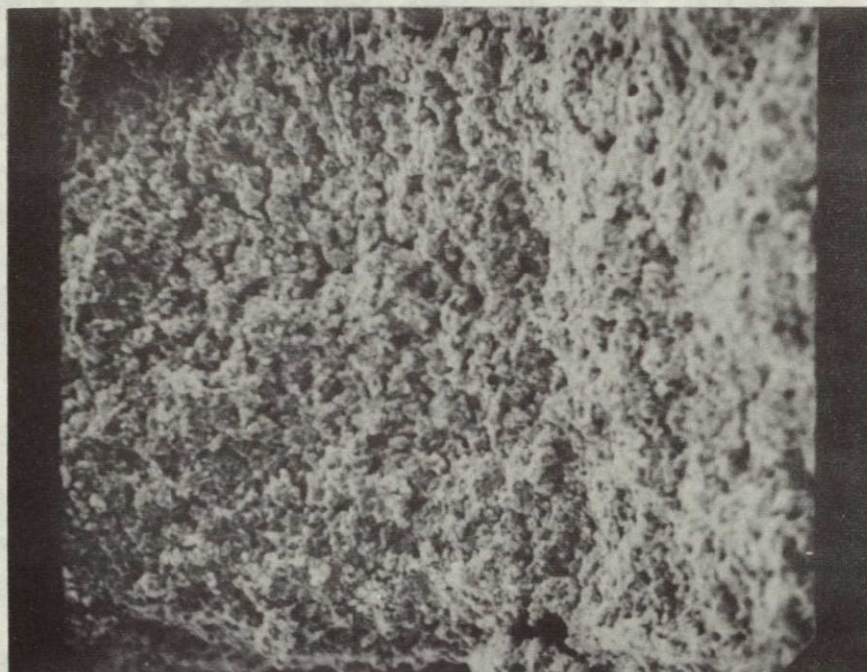
Silver Oxide Plate No. 206

Sterilized

Flat Surface

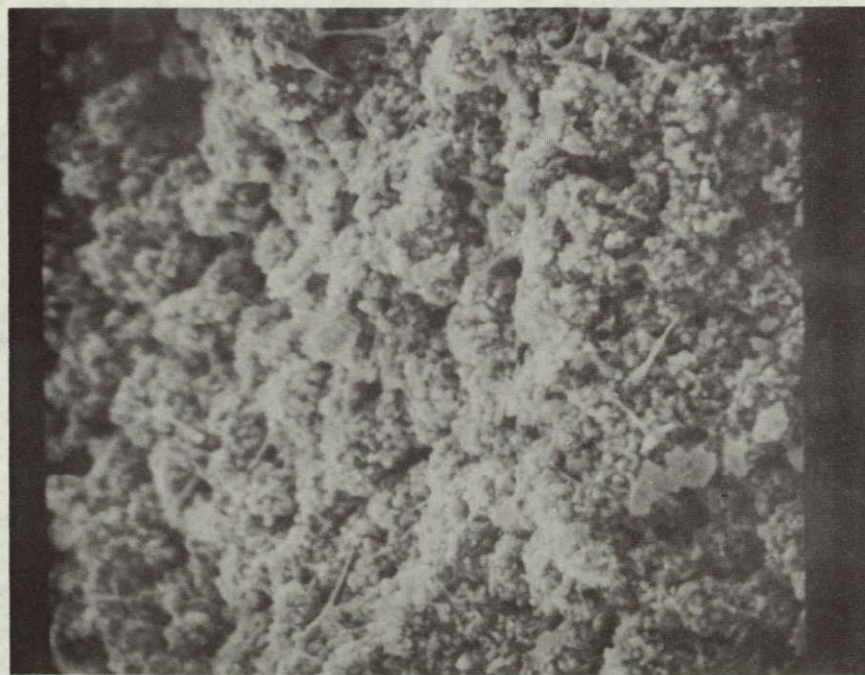
Silver Oxide Plate No. 252

As Received

Flat Surface

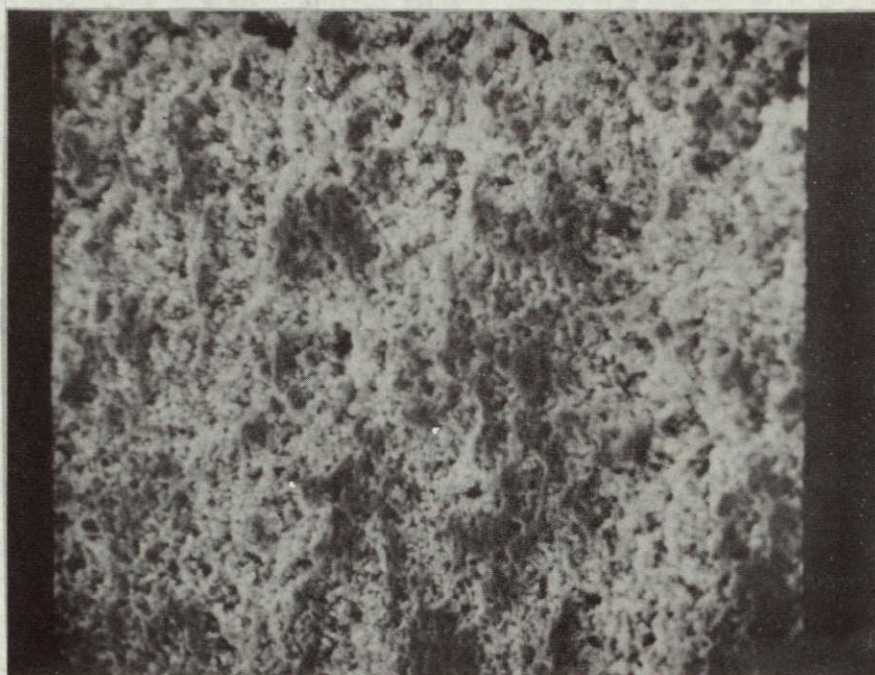
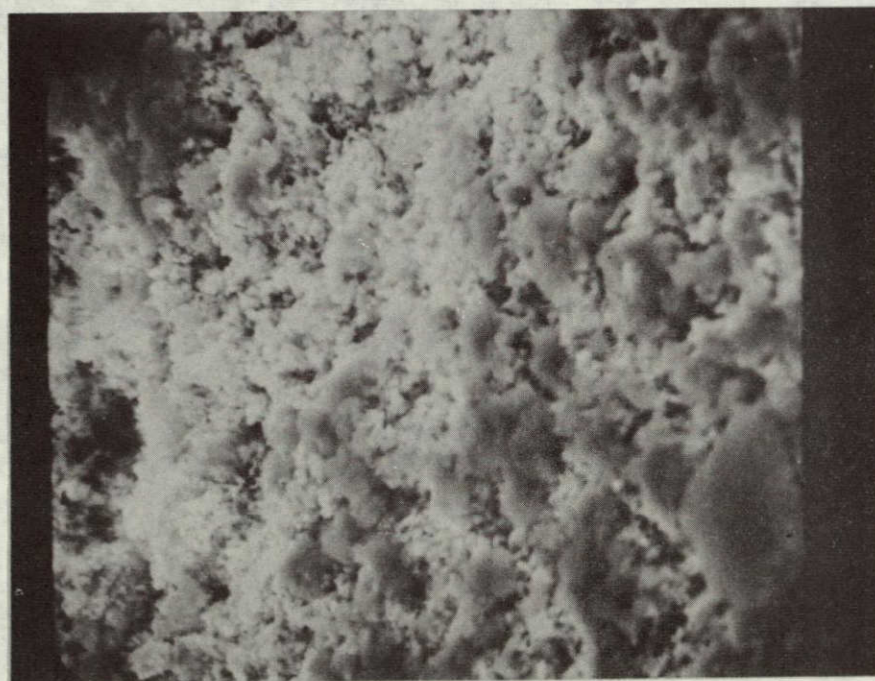
Zinc Plate No. 162

Sterilized

Flat Surface

Microscope scanning of zinc electrodes indicates that no significant changes occur in the physical structure as a result of heat sterilization. This was verified by B.E.T. surface area measurements.
